Dynajet® high pressure cleaners refurbish historic museum in Switzerland

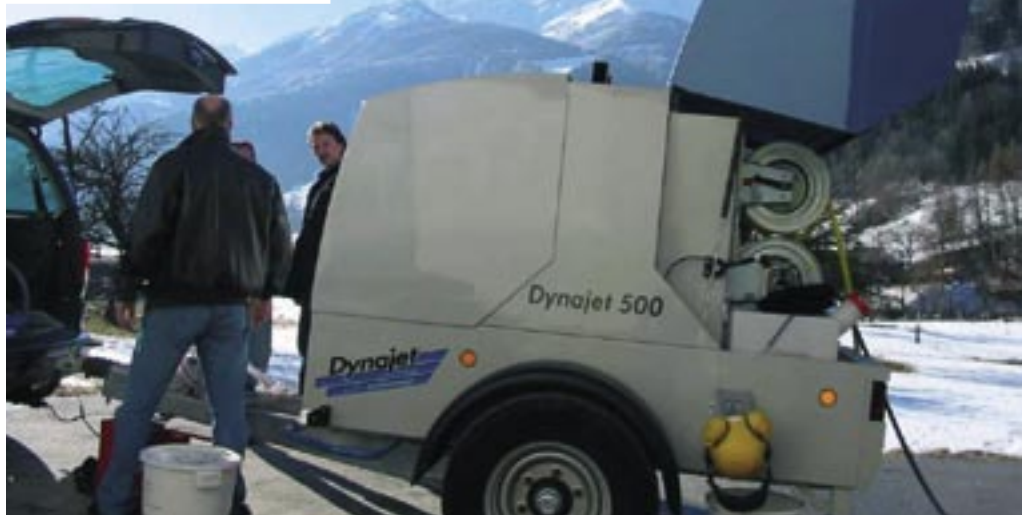
An ideal setting to work in. In the background the Swiss Alps of Wallis. In the foreground the Dynajet® 500th.

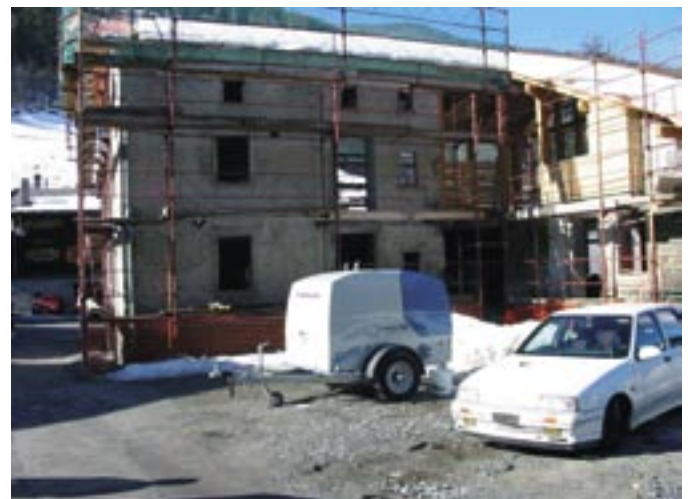
The historic museum had been plastered over in the course of time. Now one wished to return it to its original state with the natural stone masonry on show

During the course of complete restoration, the original state of the building was to be re-established in March 2003. The job here was to remove the plaster so that the original granite brickwork could be brought to light again. Here it was of course important not to damage the old brickwork and to preserve it as far as possible.

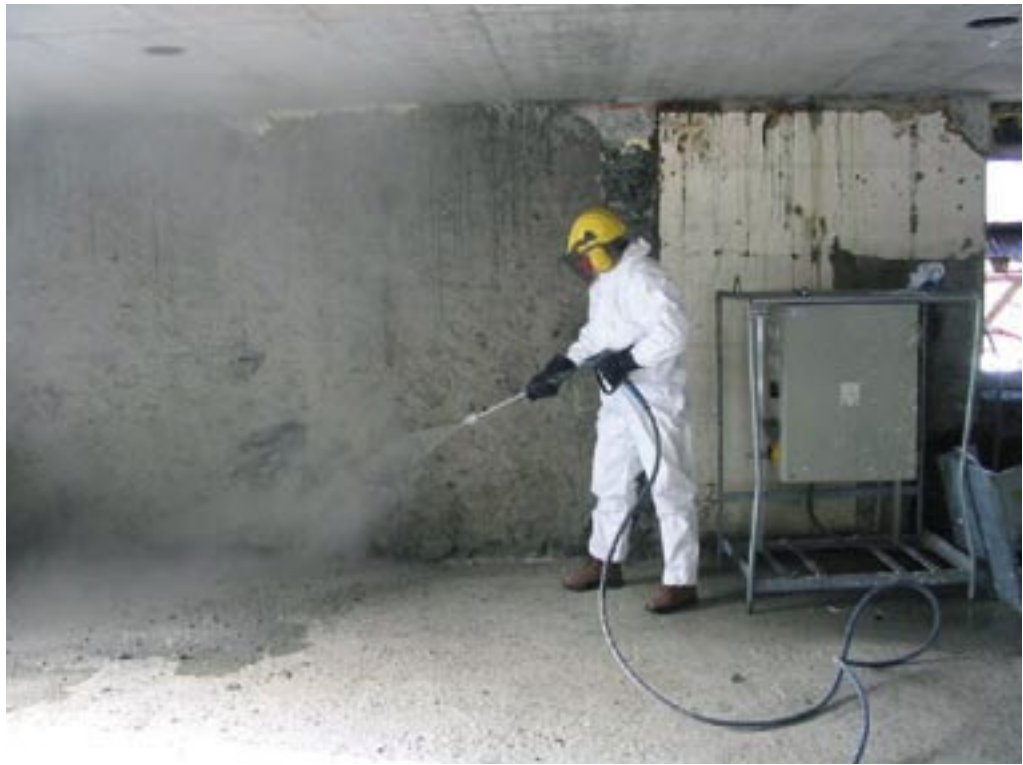
With 500 bar water pressure, the old plaster was easily removed – quickly, cleanly and free of dust.

The best results and the largest possible surface performance were then attained with a water pressure of 500 bar and the use of a rotor nozzle.

The rotor nozzle had clear advantages over the flat jet variant. Its bundled spot jet easily penetrates the centimetre thick layers of mortar, and forms a cushion of water between the brickwork and the mortar. This then just simply „blasts off“ the plaster. The plaster then fell off in great slabs and the job was carried out in record time.

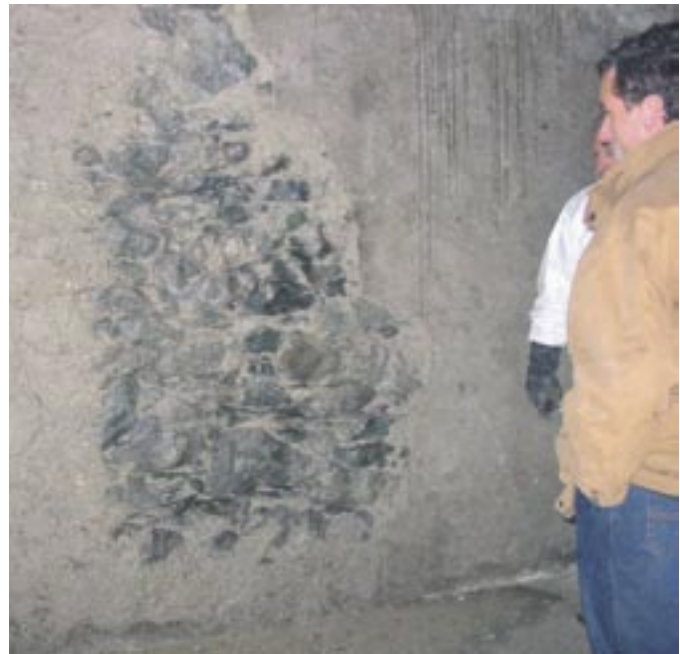
Here you can see a part of the original granite masonry – after the mortar has been 'tackled' by a 500 bar water jet.

And neither the stone surface nor the wall joints were damaged. An absolute „clean“ result!
